Braselton National Register Historic District

Popular Documentation Report

Historic American Building Survey (HABS) No. GA-2404

Prepared for
Town of Braselton, Georgia

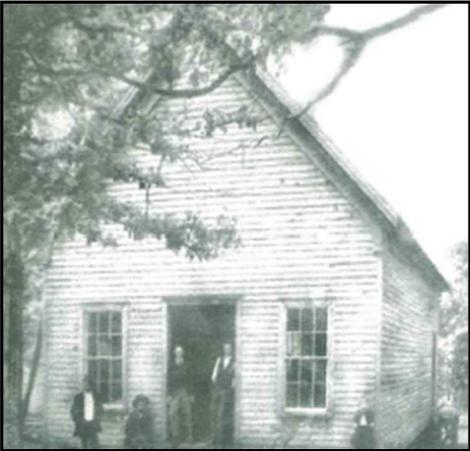
Figure 13: Third Braselton Store – 1891
(image from *Passing*)

With their continued success, the Braseltons replaced the second store with a larger third store in 1891. It measured 22' x 50'. As business continued to increase, the brothers added 22 additional feet at the rear of the third store.

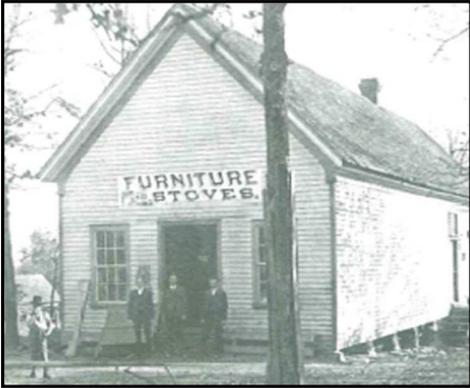
Figure 14: Third Braselton Store with 22
Additional Feet at Rear – 1894
(image from *Passing*)

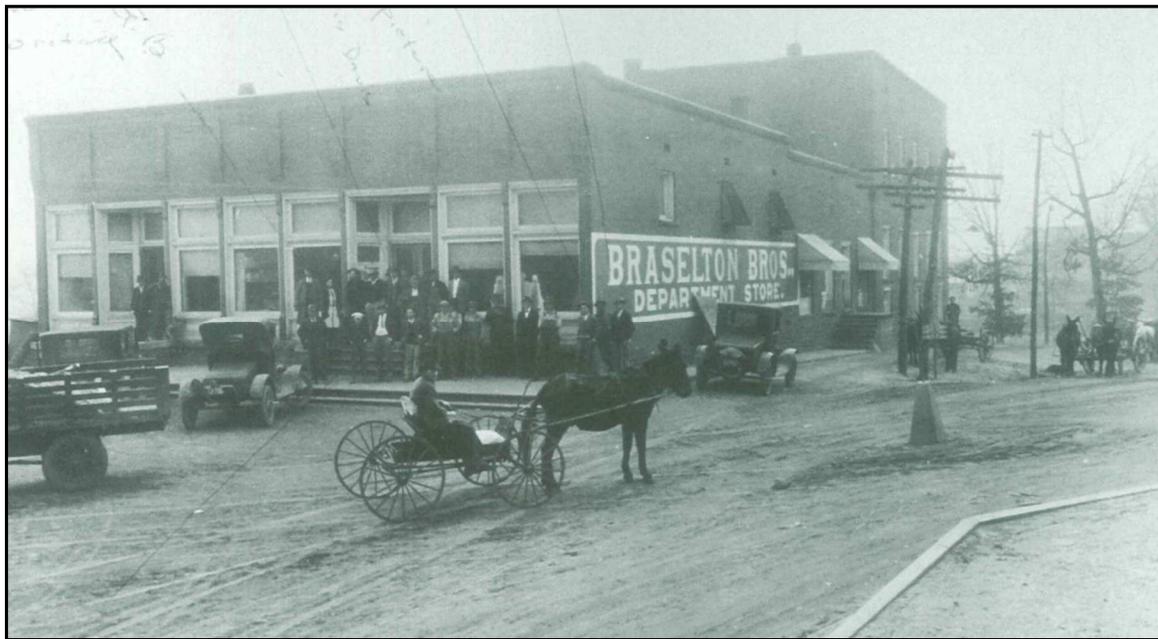
Figure 18: Fourth Braselton Store -- 1927, with Three-Story Addition at Rear
(image from *Portraits of a Southern Place*)

By the time this new brick store was constructed, the business had expanded from selling candy to selling dry goods, notions, shoes, millinery, clothing, and groceries. Already the largest building in Braselton, the store was expanded to 28,000 square feet in 1910, with the addition of a three-story building to provide additional space for the store and offices.

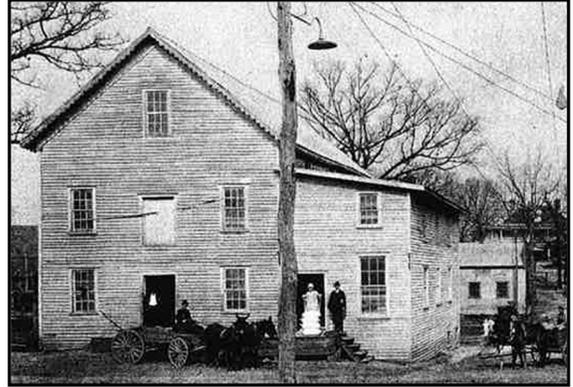
Figure 22: Historic Photo of Rolling Mill
(image from *Treasured Memories*)

The presence of the railroad spurred industrial development to take advantage of the agricultural production in the area. In 1900, the Braselton Brothers had constructed the large rolling mill to the south of the store on the west side of SR 53. The rolling mill, known as the Enterprise Flour and Grist Mill, was one of the earliest fully-operating rolling mills in northeast Georgia. It survives today as a rare representative example of an early 20th century steam-powered rolling mill in Georgia. According to the 1907 article in the Atlanta Saturday Evening News, the rolling mill had the capacity to produce 50 to 75 barrels of flour and 300 bushels of meal per day. The brothers sold their products under the labels of the “Three B’s” and “Fast Flyer.”⁸

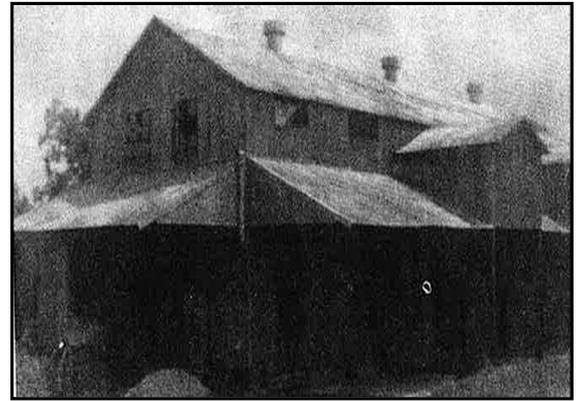
Figure 23: Historic Photo of Cotton Gin
(image from *W.H. Braselton*)

Following the construction in 1902 of the railroad spur along Wall Street, the Braselton Brothers, during the early 1900s, constructed a Cotton Gin along the siding. The gin contained a complete Murray suction ginning system and had the capacity to gin some 2,000 bales of cotton per season.⁹ The ability to ship cotton directly from Braselton made it possible to keep more money in the community, rather than to pay dealers in Gainesville, Jefferson or Athens to process the cotton. This led to an expansion of the family businesses and an overall increase in wealth for the Braselton family and residents.

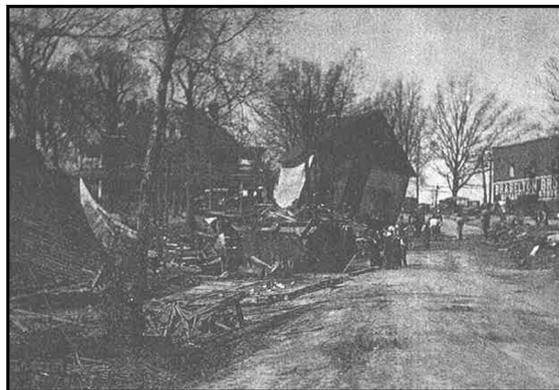
The next year, 1920, was one of the worst years for the Braselton Brothers. Not only did the cotton market crash in Georgia and the south, but a tornado swept through Braselton destroying the brand new school, the rear fourth of the brick store, the old frame store, as well as other buildings in town. In addition to the \$110,000 loss from the physical destruction caused by the tornado, the Braselton Brothers lost \$150,000 from customers unable to pay their bills at the store.

Figure 28: Third Store – Tornado Damage
(image from *W.H. Braselton*)

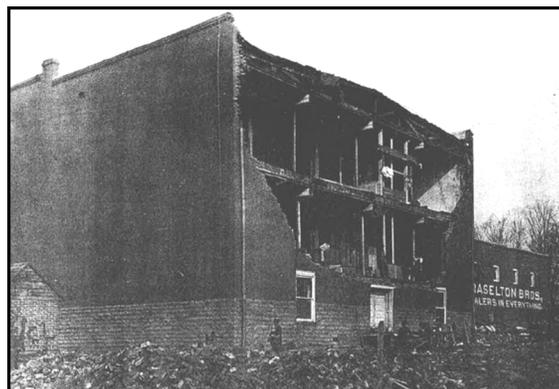
Figure 29: Fourth Store – Tornado Damage
(image from *Treasured Memories*).

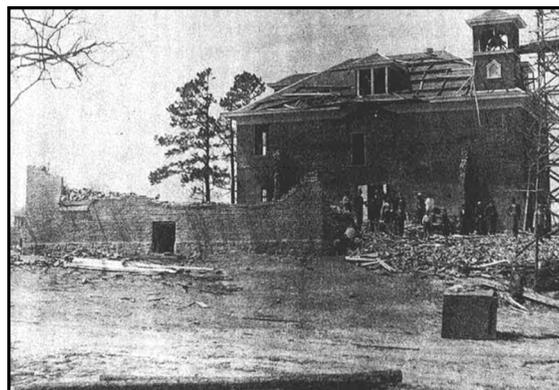
Figure 30: Braselton High School -- Tornado Damage
(image from *Treasured Memories*).

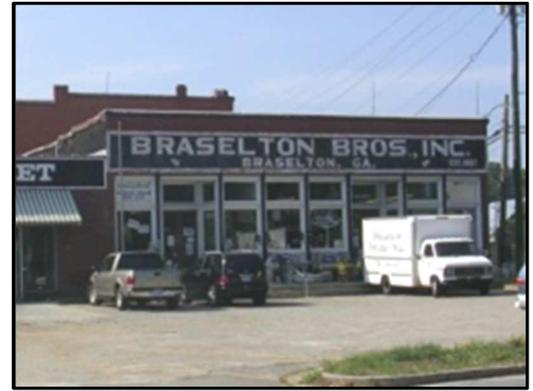
Figure 40: Façade of Braselton Antique Mall (photographer facing south).

The Braselton Brother's Store, constructed in 1904, with additions in 1910, 1940s, and 1950s, is a 29,870 square foot commercial structure on 2.38 acres of land. It is comprised of a row of one-story attached brick buildings running east to west with an L-shaped section of the building comprised of three stories. The floor structure is reinforced concrete and the wall structure is brick masonry on concrete block. The store has a flat roof of tar and gravel with stepped parapet walls at the roof with terra-cotta coping. Fenestration consists of bands of large single-pane wood display windows with single-pane wood transoms. The doorways are recessed entrances with large single wood doors consisting of a central single-pane of glass. The store retains historic signage, including the "Braselton Bros. Inc." sign above the window transoms.

The interior of the store is an irregular floor plan. Interior flooring is historic wood pine and non-historic vinyl tile. Walls are painted masonry, and ceilings are historic wood pine and non-historic Celotex fiberboard. The site is flat and consists of asphalt pavement and gravel. A concrete sidewalk and granite curb are located along the north and west elevations, between the roadways and parking. Wall Street is located behind the store to the south and east. There are no extant outbuildings associated with the building. The current condition of the store is good. The building appears to have been well maintained and is currently being used as retail stores.

The Braselton Brother's Store is architecturally significant as an excellent representative example of the multiple resource type of historic commercial buildings as defined in the Georgia Resources Survey guide. This type of historic resource typically includes two or more one-story attached units built together with identical façades and storefronts, and usually three-bays wide. This commercial building type was generally built in Georgia from the 1890s into the 1930s. The character-defining features of the Braselton Brothers Store include a row of one-story brick stores with flat roofs and parapets, terra-cotta coping, historic signs, bands of windows with transoms, large display windows, recessed main entrances, and three-bay front façades.

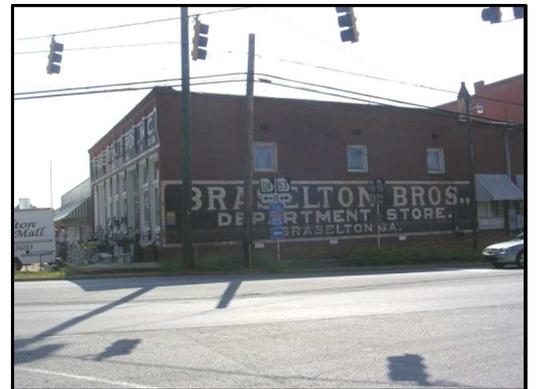
Figure 41: West Side of Braselton Antique Mall (photographer facing east).

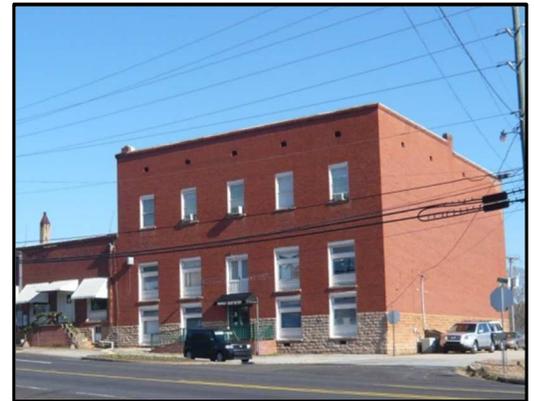
Figure 42: 1910 Three-Story Addition to Braselton Brothers Store (photographer facing northeast)

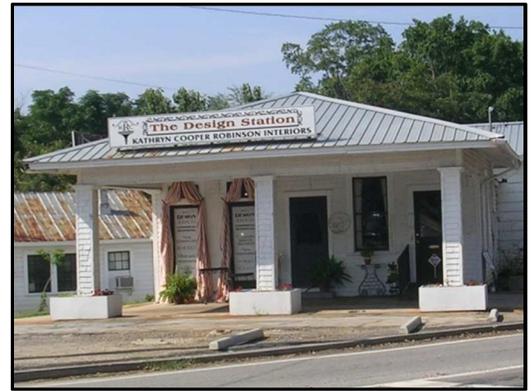
Figure 44: Façade of Old Gas Station (photographer facing southwest)

The Gas Station, constructed ca. 1925, is a one-story, square-shaped commercial building with a three-bay central block. Representative of an early 20th century commercial gas station, the building is of wood frame construction and the exterior walls are clad with wood shingles. Flat wood corner boards are located at the exterior corners of the building and the foundation is rectangular-shaped brick masonry piers. The low-pitched hipped roof is clad with standing seam metal roofing and the wide overhanging eave has exposed rafters.

The building has a large pull-through bay covered by a canopy that is part of the building's main roof and supported by three square columns that are clad with wood shingles. The site is flat and consists of concrete pavement and gravel in the front and on the sides. A wooded area is to the rear. A concrete sidewalk and granite curb are located at the front of the site adjacent to the roadway.

Currently in use for commercial retail purposes, the Gas Station is an excellent example of an early 20th century gas station with its low-pitched hipped roof and incorporated canopy, along with overhanging eaves, and three-bay central block.

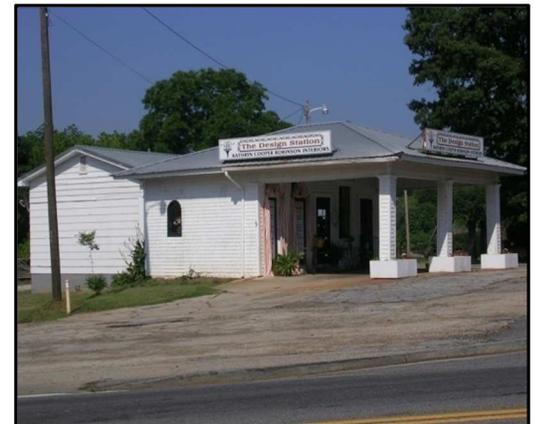
Figure 45: East Side of Old Gas Station (photographer facing west)

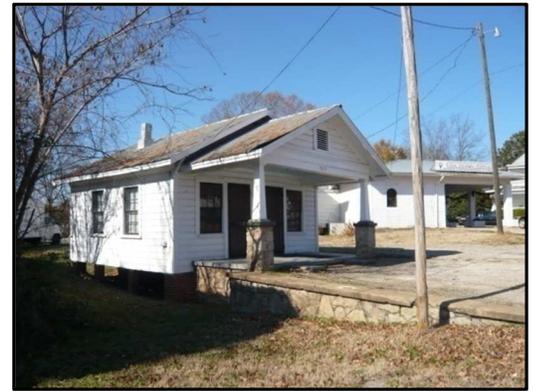
The Scott Building, constructed ca. 1920, is a one-story rectangular-shaped commercial building sited east to west and oriented east toward SR 53. Representative of an early 20th century front-gable commercial building constructed with Craftsman-style elements, the building is of wood frame construction and the exterior walls are clad with wood drop siding. There are wood brackets, comprised of 2" x 4" boards at the corners of the east and west elevations. The building foundation consists of brick masonry piers. The front gable roof is clad with standing seam metal roofing and the wide overhanging eave has a simple wood board cornice and exposed rafters. There are two brick chimneys located at the interior slope of the roof.

The building has a projecting front gable porch that is supported by two tapered wood posts, supported by square piers of fieldstone with stone caps. The porch foundation is comprised of a fieldstone foundation wall at the south elevation of the porch. The porch floor is made of poured concrete painted grey.

The site slopes down from north to south and consists of gravel and grass at the east (front) and north (side) of the building. A fieldstone foundation wall is located at the south side of the site, marking the transition of the grade change from north to south. A concrete sidewalk and granite curb are located at the front of the site adjacent to the roadway.

Figure 47: Scott Building
(photographer facing northwest)

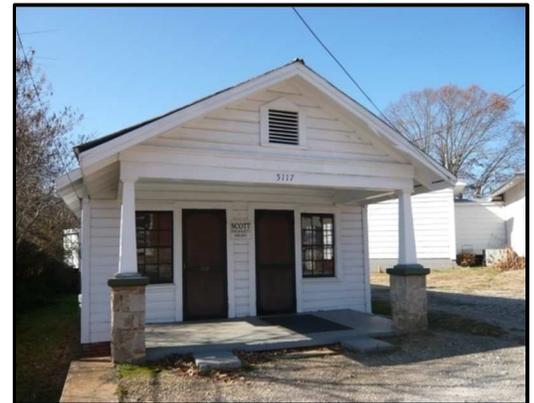
Figure 48: Façade of Scott Building
(photographer facing west)

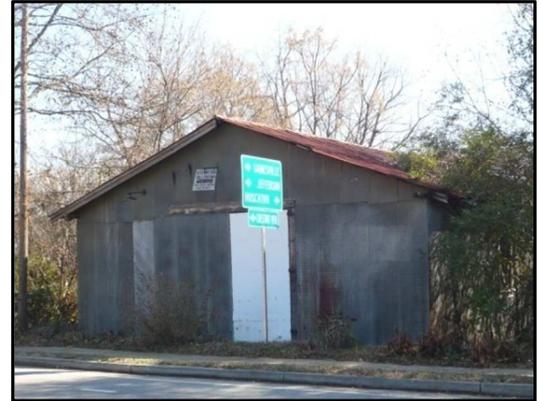
Figure 50: Façade of Auto Garage (photographer facing southeast)

There are four windows in the building, with two located on each of the east and west elevations. These are six-over-six double hung wood sash and frames with casings of flat boards at the jambs and head. There are no shutters on the windows. The windows are in deteriorated condition, with many of the sash and panes broken and missing.

The ca. 1920 Auto Garage is a good example of an early 20th century automobile garage with its one-story height, front gable roof, wood frame construction, and two large bay openings.

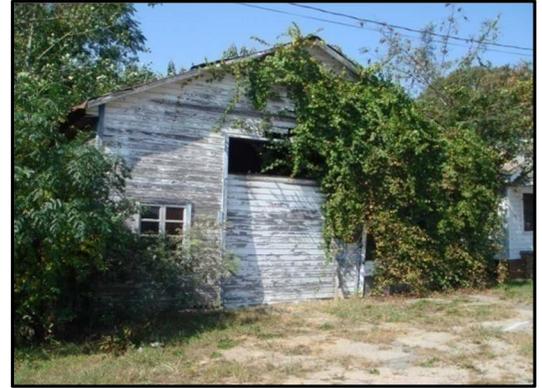
Figure 52: Façade of Braselton Tire Company (photographer facing west)

The Tire Company is representative of a simple commercial building type associated with automobile repair in the early to mid-twentieth century.

The building is constructed of wood frame on a one-story rectangular plan with a front gable roof and large single-bay garage door opening at the façade.

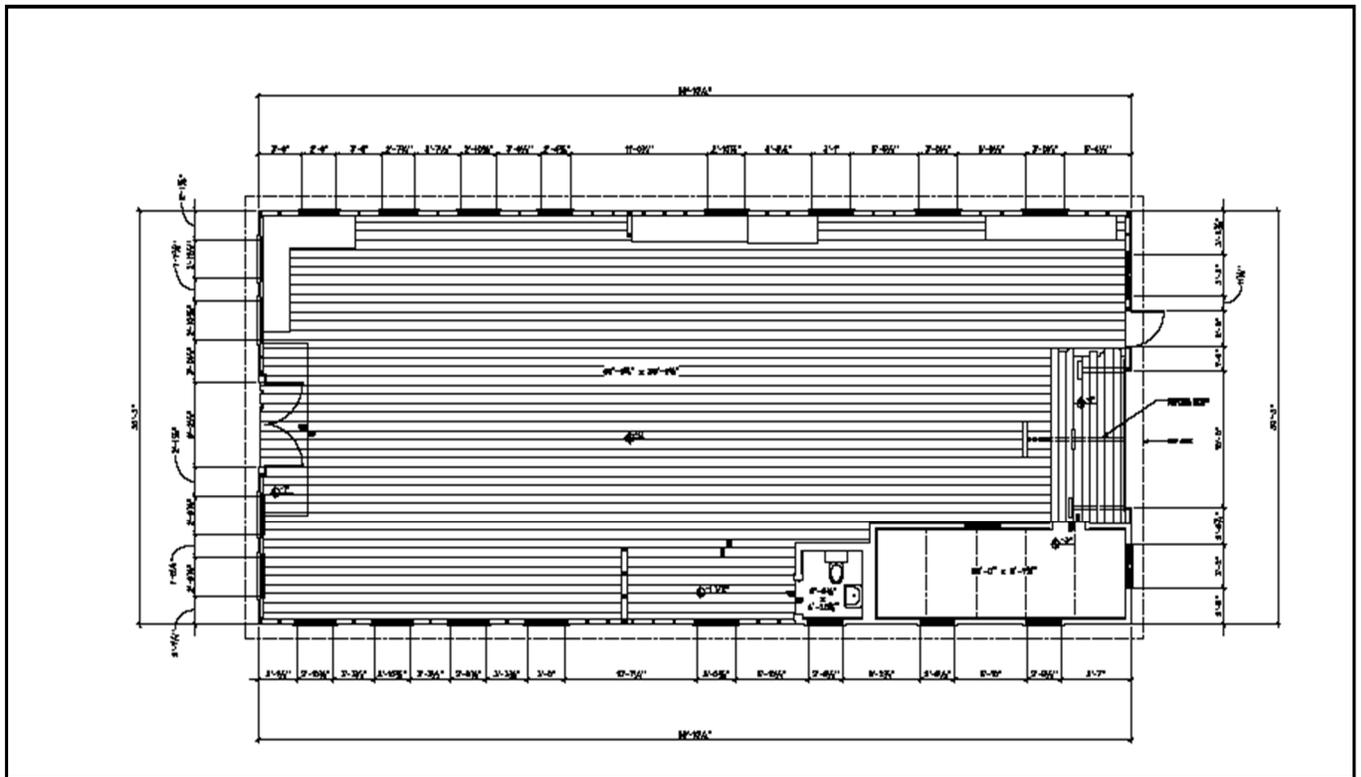
Figure 53: Floor Plan of Braselton Tire Company – Façade/Front Facing to the Right

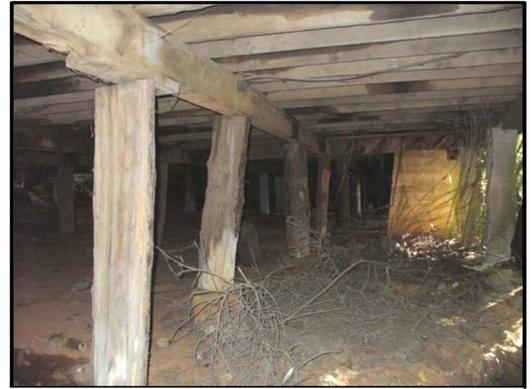
The foundation is comprised of piers made from a variety of building materials. Several piers are constructed of brick and supported by natural stone bases. Other piers are made of poured concrete and supported by natural stone and brick bases. One pier is a half-round split log on natural stone base.

Figure 54:
Foundation Piers of Braselton Tire Company
(photographer facing east)

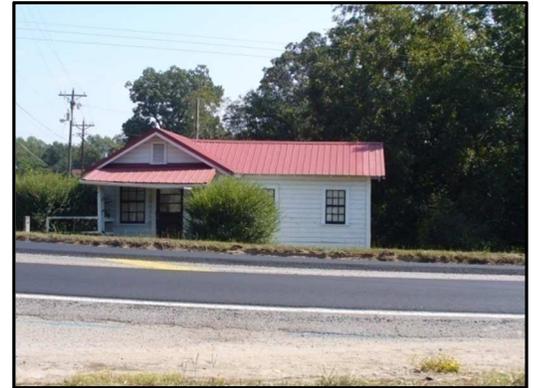
Figure 57: 1957 Telephone Exchange (photographer facing east)

Constructed ca. 1920, the 1957 Telephone Exchange was most likely constructed as a single-family residence. By 1927, this building became the headquarters of Braselton's new telephone system. The one-story wood frame building has an L-shaped plan with gable roof, overhanging eaves, and exposed rafters.

The foundation walls on the west and north elevations are one to two courses of field stone at grade with two to three courses of brick laid atop. The concrete porch foundation wall at the north elevation and the foundation wall at the west elevation are cracked and displaced along the mortar joints. There are several holes in the foundation wall concrete blocks at select locations. Several of the foundation vents have torn and missing screens.

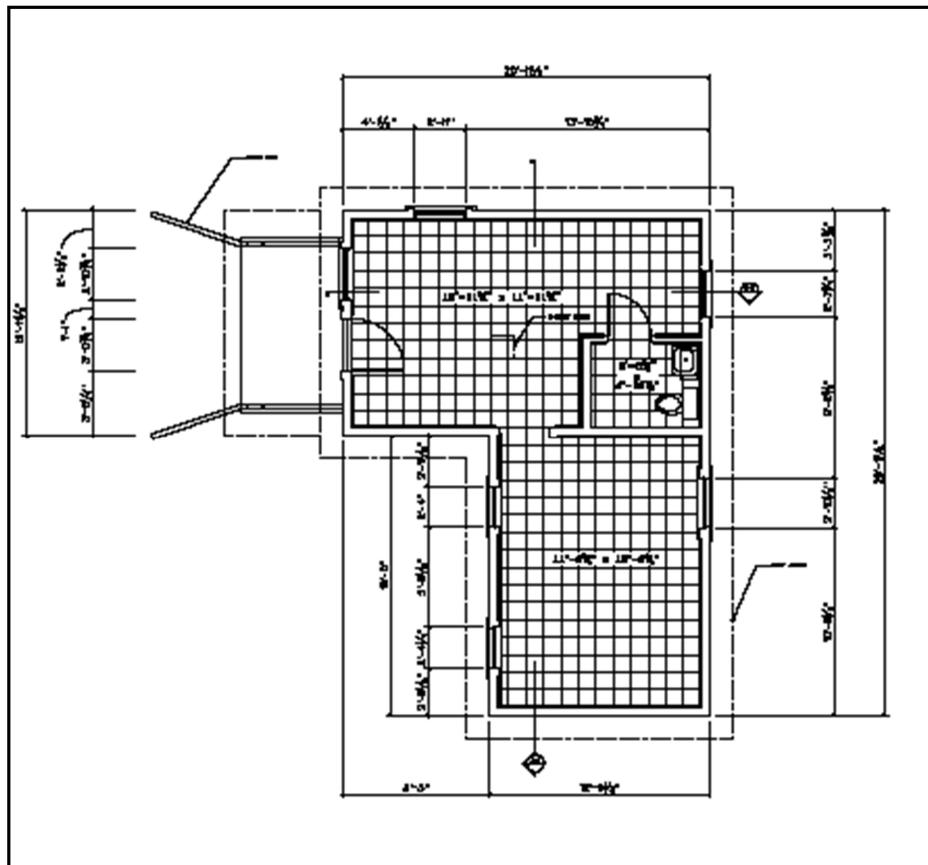
Figure 58: Floor Plan of the 1957 Telephone Exchange – Façade/Front Facing to the Left

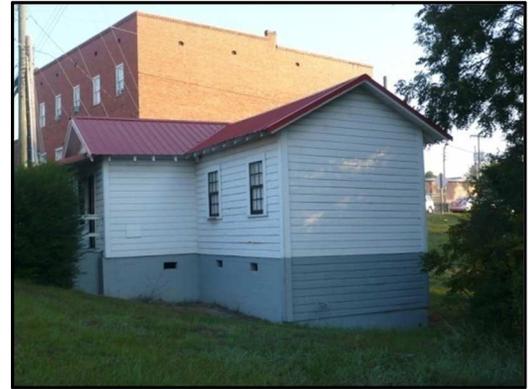
Figure 59: Front Oblique View of Telephone Exchange (photographer facing north)

The 1957 Telephone Exchange Building represents the early-twentieth century modest residential dwellings in Braselton and the evolution of technological advancement as the home of the Braselton Telephone System beginning in the mid-1920s. This building is also significant architecturally as a good example of the gable ell building type constructed with Craftsman-style elements.

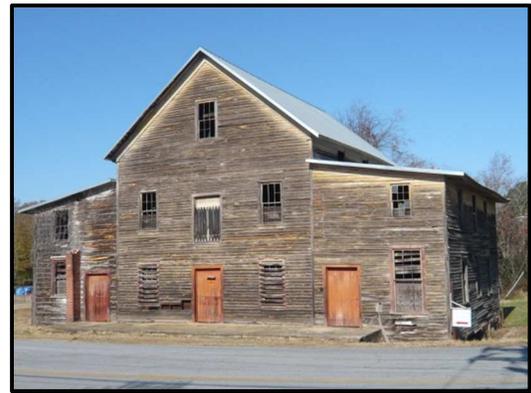
Figure 66: Façade of Rolling Mill
(photographer facing north)

The building is of wood frame construction and the exterior walls are clad with unpainted wood weatherboard with corner boards of flat wood. The foundation consists of square timber and triangular cement piers. The central front gable roof is clad with standing seam metal roofing, as are the shed roof side sections. The roof has a wide overhanging eave with a simple fascia board forming the eaves. The gable ends have a raking cornice comprised of a flat wood board.

The mill has three exterior doors on the south elevation that are comprised of vertically-oriented wood. The doors have simple casings of flat wood at the jambs and head. Windows are six-over-six double hung wood sash and frame with wood sills and simple wood casings at the jambs and head. Several windows have been in-filled with weatherboard and many have broken and missing sash and panes. The side addition rooflines bisect the second story windows of the original building.

The mill is significant as an example of an early 20th century rolling mill with its two and one-half story height, side-gable metal roof, weatherboard exterior siding, and one-bay side additions.

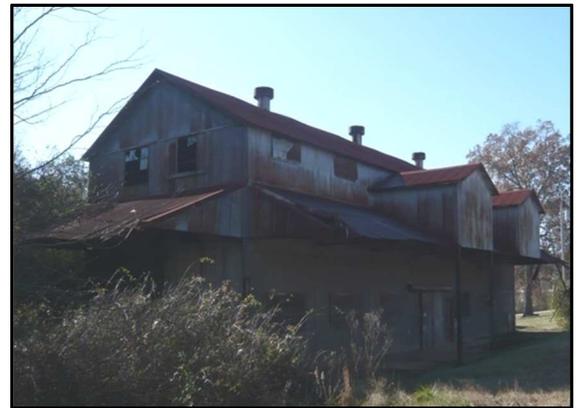
Figure 69: Oblique View of Cotton Gin (photographer facing southwest)

The Cotton Gin is significant as an example of an early 20th century cotton gin with its two-story height, side-gable metal roof, metal exterior siding, covered wagon entry, and wrap-around porch.

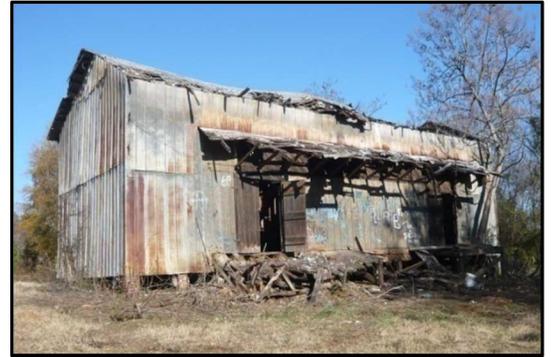
Figure 71: Cotton Seed Storage Building
(photographer facing north)

The structure is constructed of wood frame on a raised one-story rectangular plan with a side gable roof and four pair of double wood batten doors.

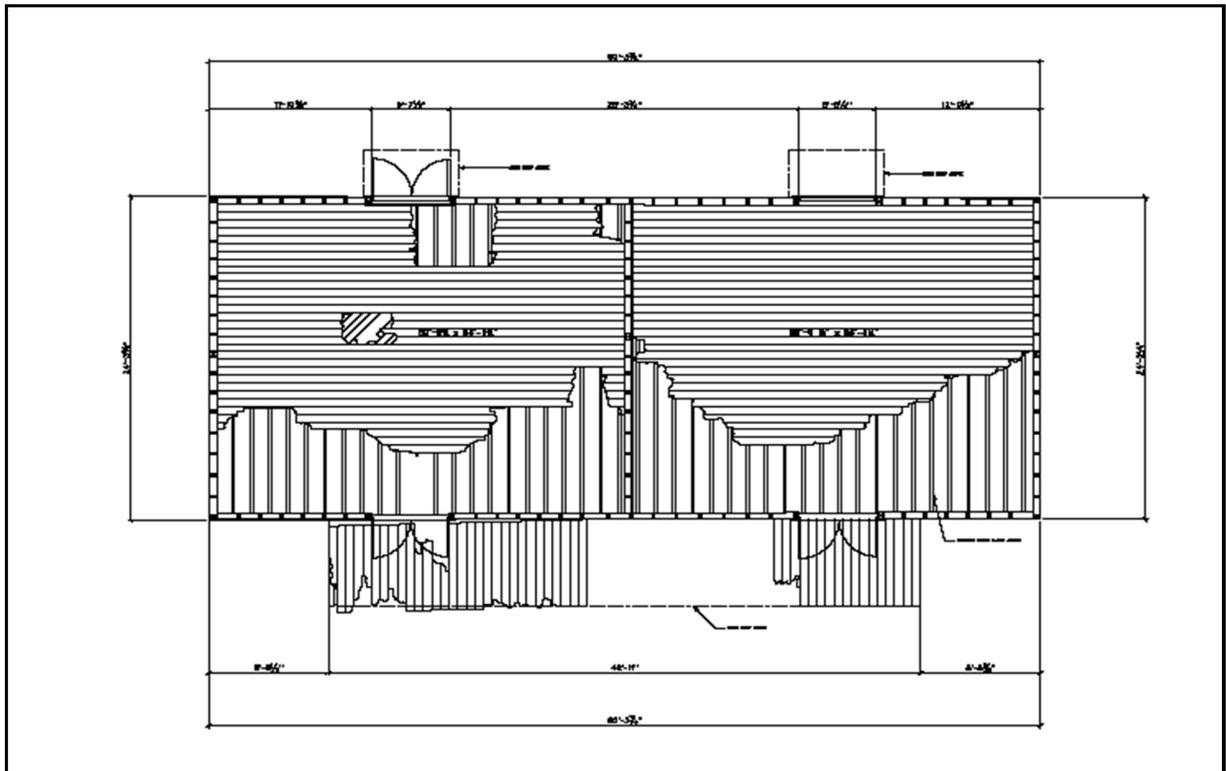
Figure 72: Floor Plan of Cotton Seed Storage Building

The raised foundation is comprised of timber and brick masonry piers that support 2" x 8" wood beams that run east to west along the length of the building. The timber piers are 8" x 12" timbers with 2" x 6" diagonal wood bracing. Many of the timber piers rest on flat stacked natural stones, while others extend below grade.

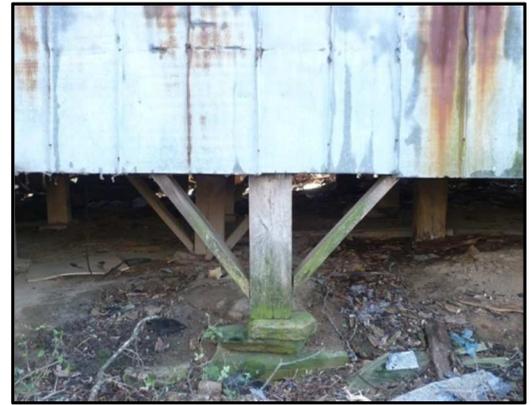
Figure 73: Timber Pier on Stone Footings
(photographer facing north)

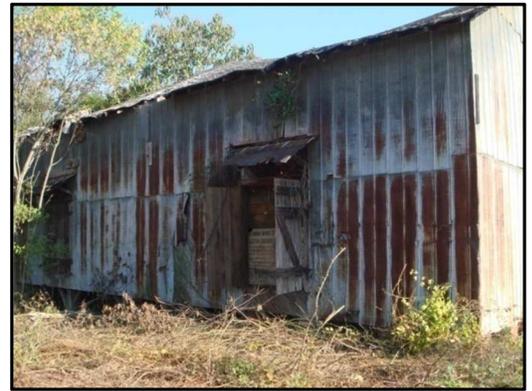
Figure 74: Vertical Sheet Metal Wall Cladding
(photographer facing southeast)

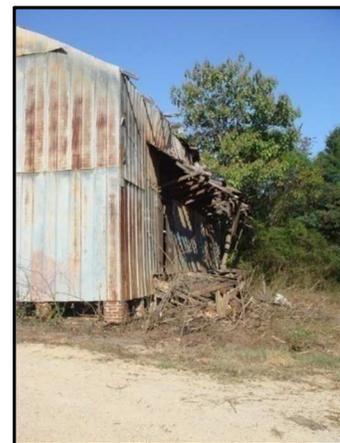
Figure 75:
Wood Loading Dock and Awning
(photographer facing northeast)

A wood frame loading dock and awning are located along the south elevation of the building. The dock and awning measure 42'-11" in length. The flooring of the loading dock is 7 1/2" boards.

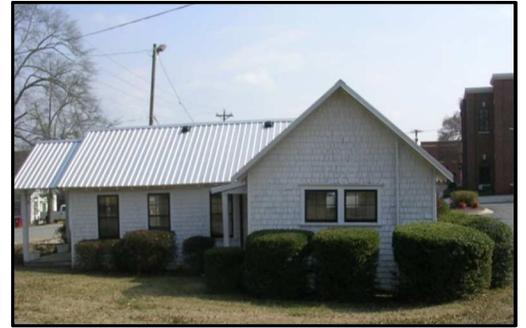
Figure 78: Braselton Visitors Center
Former Home Economics Department
(photographer facing northeast)

Built in the late 1920s, the Visitors Center was used historically as the Home Economics Department for the high school, and it later served as the Braselton Library. Despite this change in use, the gymnasium?? serves as a good representative example of the type of school building used in early 20th century Braselton, and displays such character-defining features as a front-gable roof, wood-frame construction, overhanging eaves with exposed rafters, six-over-six double-hung windows, projecting gable-roof front porch, and wood shingle siding.

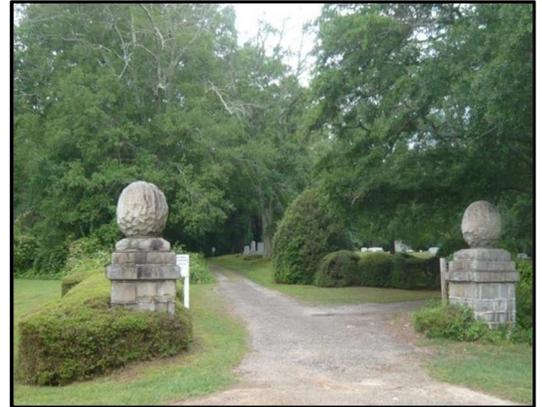
The cemetery was founded by the Braselton family in 1929 and at the entrance are two decorative stone markers featuring square bases supporting large rubble-faced cylindrical spheres.

Figure 84: Entrance to Braselton Cemetery (photographer facing west)

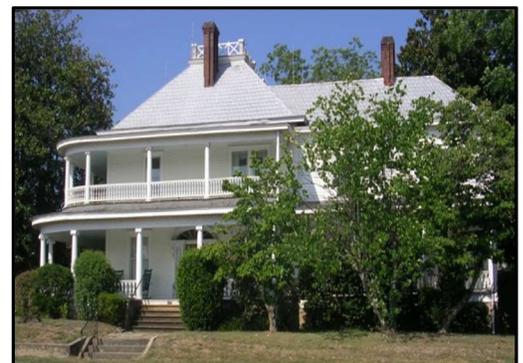
Figure 90: John Braselton House (photographer facing southwest)

The house has one- and two-story wrap-around porches with a machine-turned wood balustrade. The porches are supported by slender wood columns with Ionic capitals. The porch flooring is tongue and groove wood. Windows are one-over-one double hung wood sash and frames. The windows have flat wood casing at the jambs and heads with a projecting window hood at the head. The windows do not have shutters.

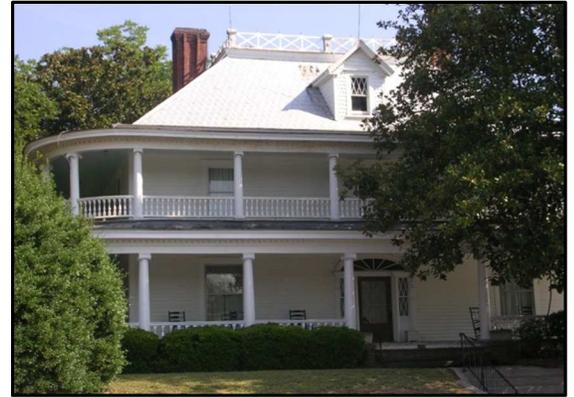
Character-defining features of this landscape type present at the John Braselton House include concrete and stone retaining walls defining the yards, stone piers marking the main drive, large hardwood trees, and a grass lawn with foundation plantings located near the house.

Figure 91: John Braselton House
(photographer facing southwest)

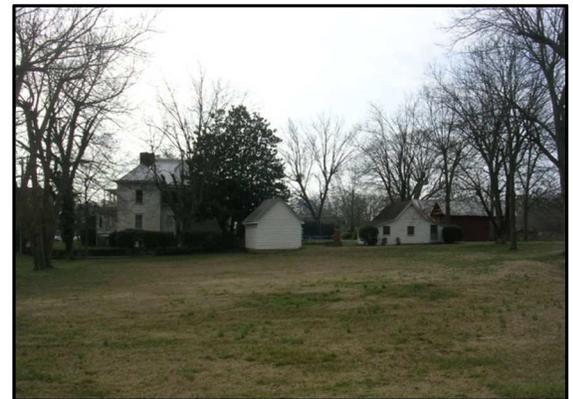
Figure 93: John Braselton House and Outbuildings
(photographer facing southeast)

Associated with the Braselton House are numerous agricultural outbuildings, located to the west of the main house. These buildings include one large transverse barn, one deteriorated large transverse barn, a smokehouse, tenant house, sheds, and a historic bell supported by concrete columns located near the outbuildings.

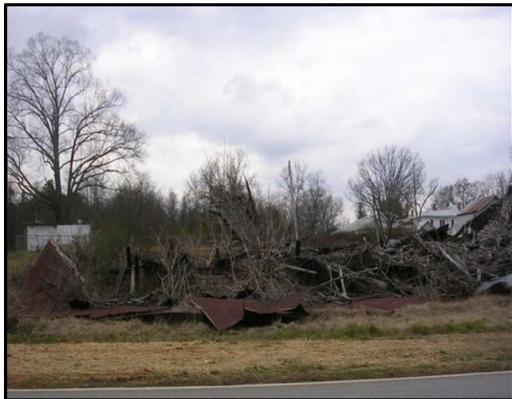
Figure 97: Collapsed Barn Southwest of John Braselton House (photographer facing northwest)

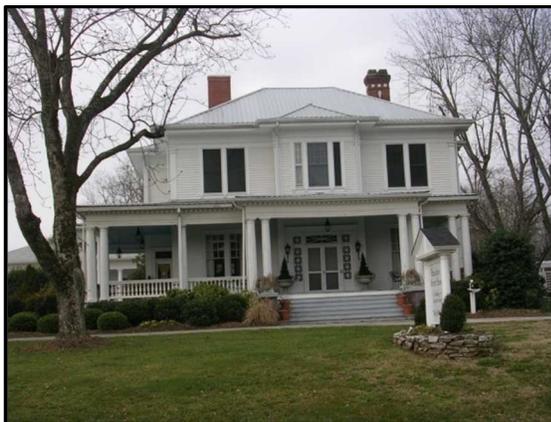
The Green Braselton House was the home of Green, May Duncan, Brassie, and Leta Braselton. Today, the house is known as the Braselton Stover House and is used as a special events facility. The house is an excellent example of the two-story Georgian House type built in the Colonial Revival style, with character-defining features such as hipped roof, interior chimneys with decorative patterned brickwork, projecting second-story front bay, double hung wood windows, one-story wrap-around porch with paired classical columns, and trabeated main entrance.

Figure 101:
Façade of Green Braselton House
(photographer facing west)

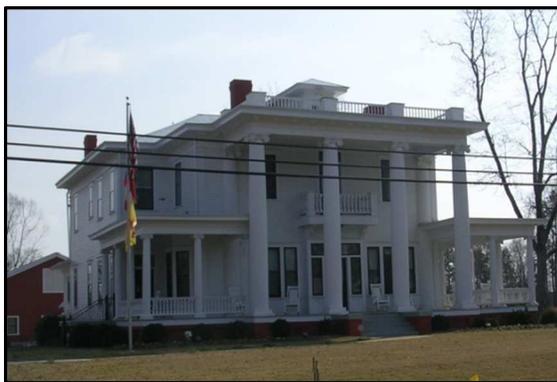
The third Braselton residence, the W.H. Braselton House, was constructed in 1913 to the south of the first two houses along SR 53. The two-story Georgian House building type was built in the Neoclassical Revival style. The house features a flat roof, modillions, dominant full-height full portico with fluted classical columns, second-story center-bay balcony, one-story side porches supported by fluted classical columns, one-over-one double hung windows, and trabeated main entrance. Much of the historic landscaping associated with the house has been lost to a parking lot. The remaining historic elements include a grass lawn and mature hardwood trees. This house is currently used as the Braselton City Hall.

Figure 105:
W.H. Braselton House/Braselton Town Hall
(photographer facing southwest)

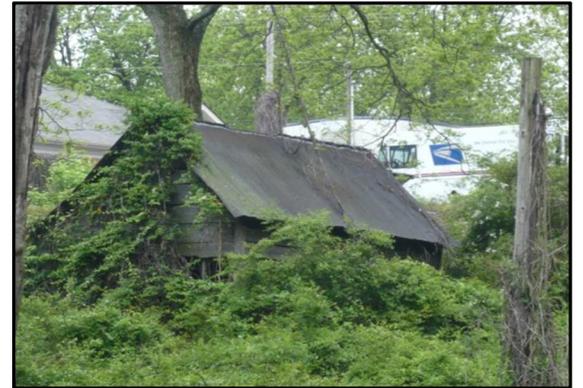
One of the oldest buildings remaining in the historic district was built ca. 1887. It is located in an overgrown lot on the northeast corner of SR 53 and SR 124 behind the existing Post Office. Originally built as a one-room store by John Braselton, the building was later enlarged to function as a central hall residential dwelling.

Figure 108: House/Second Store in Woods behind Post Office (photographer facing southwest)

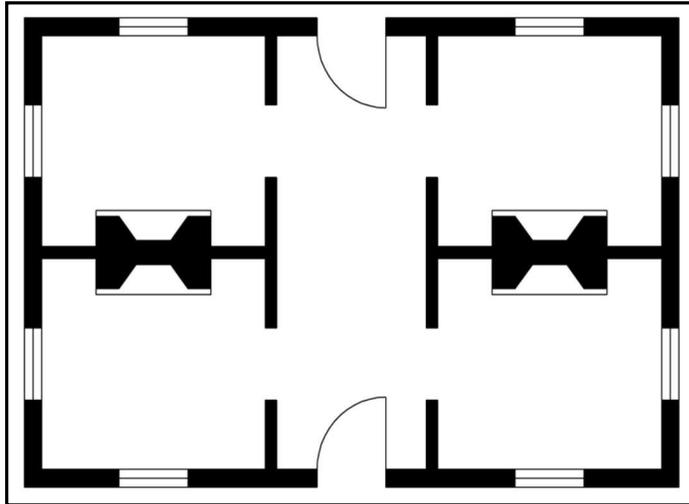
Figure 115:
Example of a Georgia Cottage Floor Plan
(image from *House Types in Georgia*)

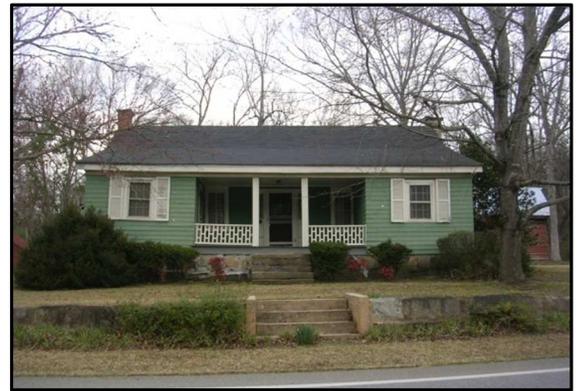
Constructed ca. 1870, this house is one of the oldest surviving buildings in Braselton. Its character-defining features include the side-gable roof, square-shaped floor plan, and interior central hallway. The setting of the house includes ornamental yard elements, such as the low concrete and stone wall with steps leading to the elevated front yard, and grass yard with foundation plantings.

Figure 114: Façade of 9608 State Route 124
(photographer facing north)

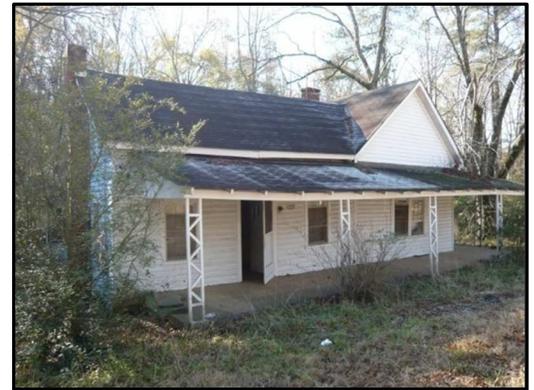
The house has two porches, with a full-width porch extending the length of the north and west elevations. This porch has a shed roof clad with asphalt shingles with exposed rafters supported by wood columns. The second porch is enclosed at the east elevation. It has a shallow-pitched gable roof clad with asphalt shingles and is supported on concrete block foundation walls.

Figure 117: Façade of Barnett House
(photographer facing south)

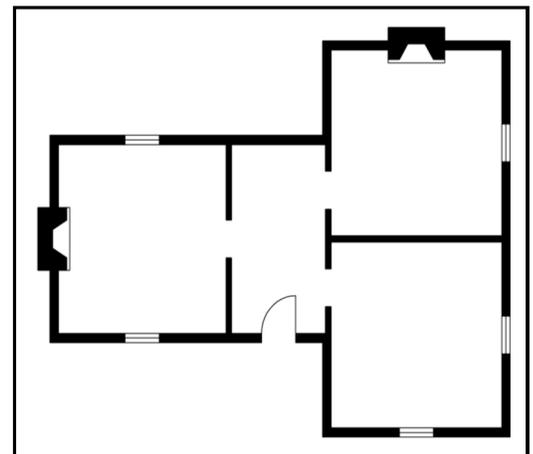
Figure 118: Example of a Gabled Ell Floor Plan
(Image from *House Types in Georgia*)

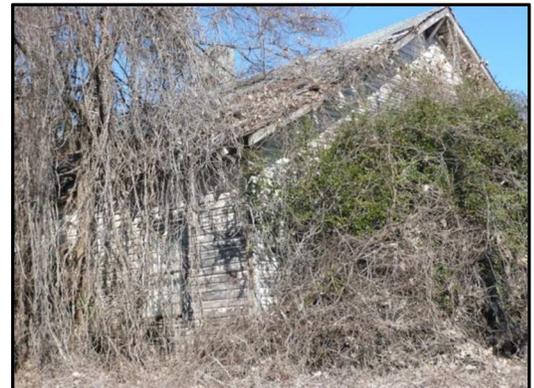
The house is sited facing east on a site that slopes down from west to east toward Jesse Cronic Road. The site consists of grass and foundation plantings with a densely wooded area north of the house. The site is overgrown with vegetation and only portions of the house are visible.

The residence is a good example of a side-gable bungalow with Craftsman-style elements; however, the house is in deteriorated condition and the roof has collapsed in several areas allowing water to enter the building.

Figure 121: Residence with Overgrown Vegetation (photographer facing north)

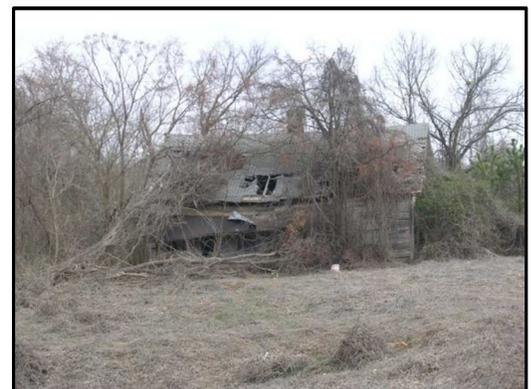
Figure 122: Residence with Deteriorating Roof (photographer facing northeast)

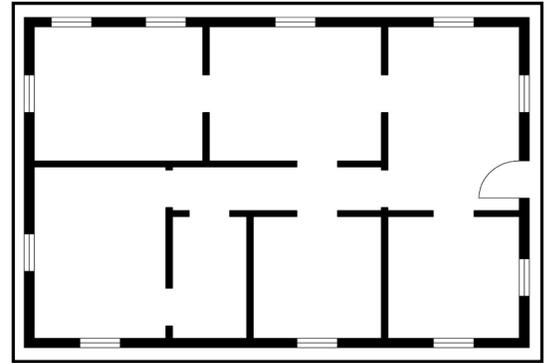
Figure 123:
Example of a Front Gable Bungalow Floor Plan
(image from *House Types in Georgia*)

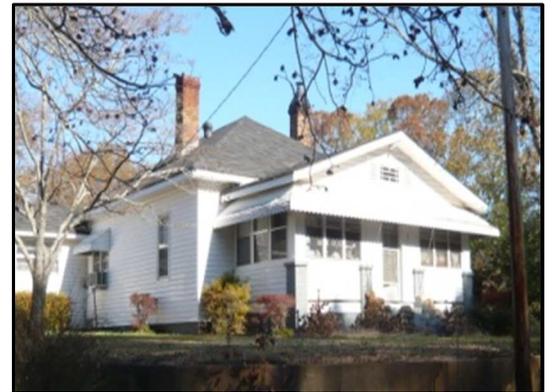
The ca. 1926 Evans House is a 2,064 square foot residential dwelling sited facing south towards SR 124 on a 9.04 acre parcel of land. The one-story house is an L-shaped plan and is a good representative example of a front gable bungalow with Craftsman-style elements situated within an intact historic landscape design. The house is of wood frame construction. While the exterior walls were most likely (and possibly still are) clad with wood clapboard, they are currently covered with vinyl siding. The foundation is square brick piers that have been in-filled with concrete block.

Figure 124: Façade of Evans House
(photographer facing northeast)

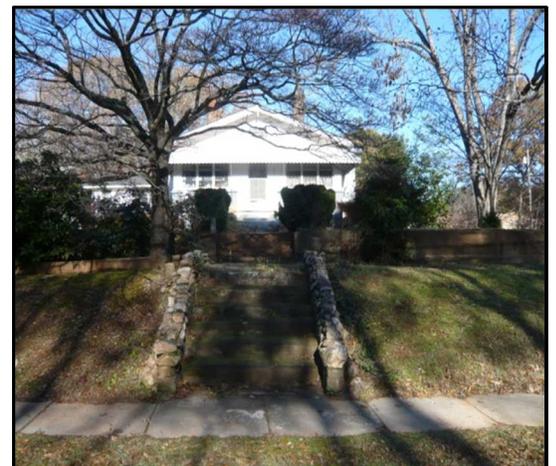
Located at the high point of its site, the historic setting of the Evans House is a good representative example of the ornamental yard, exemplified by the stone walls of the walkway from SR 124 to the elevated front yard, low concrete wall outlining the yard, and foundation plantings and grass yard.

Figure 125:
Raised Site and Stone Stairs Leading to Evans House
(photographer facing northwest)

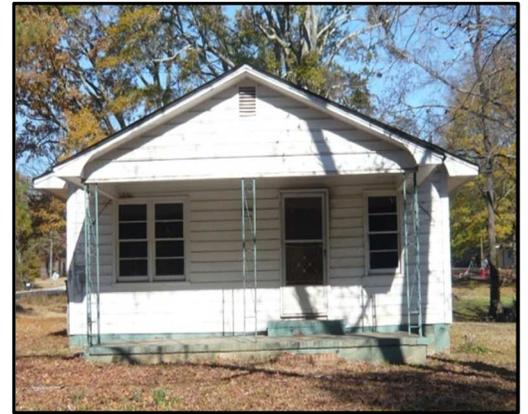
The house is of wood frame construction with exterior walls clad with wood drop siding and flat wood corner boards. The foundation walls are concrete block painted green with foundation vents at the east and west elevations. The front gable roof is clad with green asphalt shingles and the gable ends have a raking wood cornice with cornice returns.

There are two porches on the house. A front projecting gable porch is at the south elevation. This porch is supported by three decorative metal posts. The porch foundation is concrete block and the floor is poured concrete with decorative brick trim at the edges. A three-quarter width rear porch is located at the north elevation. This porch has a shed roof with green asphalt shingles and is currently in a state of disrepair. The porch is being temporarily supported by two 2" x 4" boards and the flooring has been removed leaving only the brick foundation.

Figure 126: Façade of Richardson House
(photographer facing northwest)

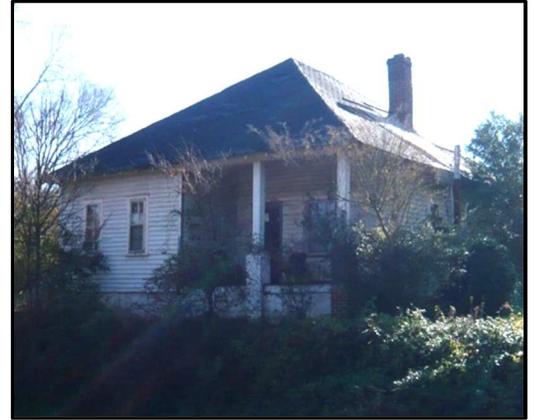
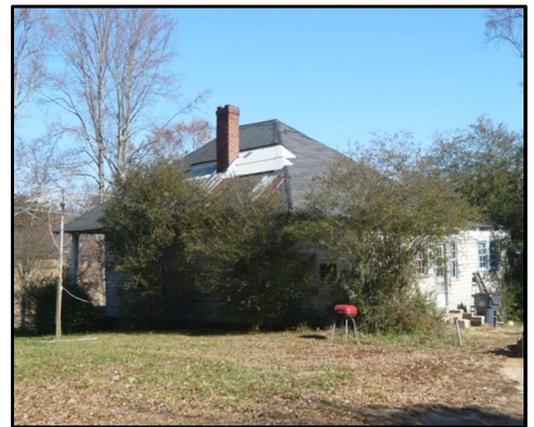
The house is of wood frame construction and the exterior walls are clad with wood clapboard. Flat wood corner boards are located vertically at each exterior corner of the house. The foundation is comprised of brick masonry piers and the spacing between the piers has been in-filled with concrete block.

The house has a front porch that is inset within the main roof at the northwest corner of the house. The porch roof is supported by two square wood posts on square brick piers. The porch flooring is flush wood boards and the ceiling is tongue and groove wood. The porch is accessed from the west side of the house via three-step wood frame stairs.

The house is sited facing north on a site that has a slight downward slope from north to south. The site consists of grass and foundation plantings with a densely wooded area south of the house. The house has suffered a fire since the initial survey for this project. The fire has destroyed the roof and a majority of the interior of the house.

Figure 129:
Front Oblique View of 9819 State Route 124
(photographer facing southeast)

Figure 130:
Rear Oblique View of 9819 State Route 124
(photographer facing northeast)

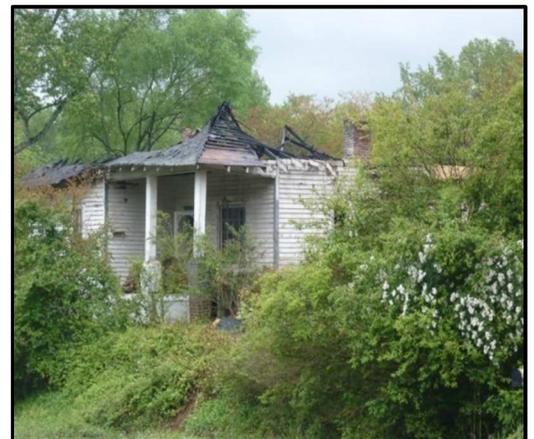
Figure 131: 9819 State Route 124 after the fire
(photographer facing southeast)

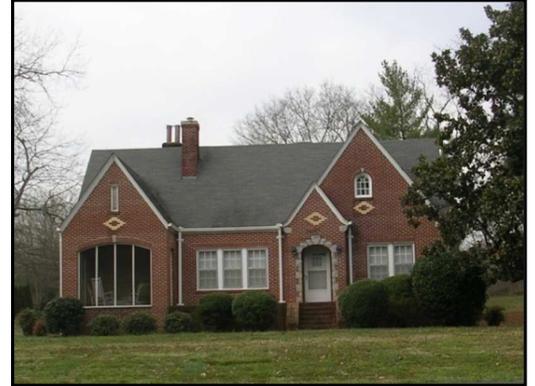
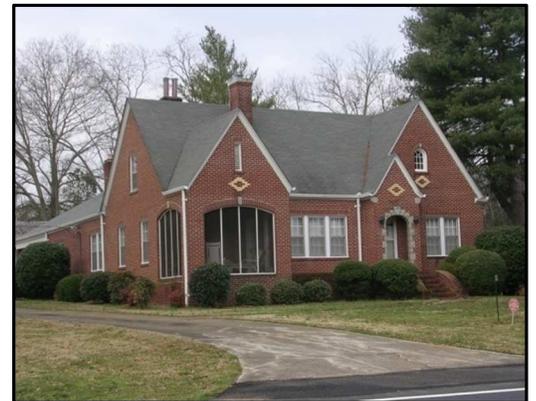
The character-defining features of this house include brick masonry walls, a steeply-pitched gabled roof with dominant front-facing gables, patterned brickwork, and stone in the front-facing gable marking the main entrance.

Figure 132: Façade of 5293 State Route 53
(photographer facing west)

Figure 133: Oblique View of 5293 State Route 53
(photographer facing northwest)

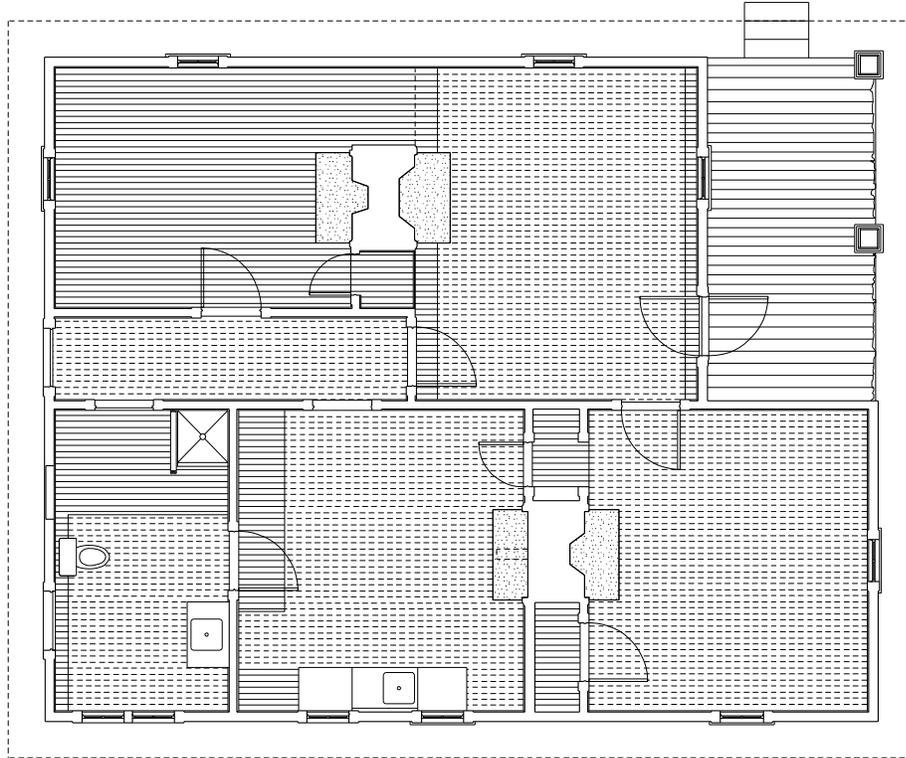
Figure 134: Floor plan of 9791 State Route 124 – Façade/Front Facing to the Left

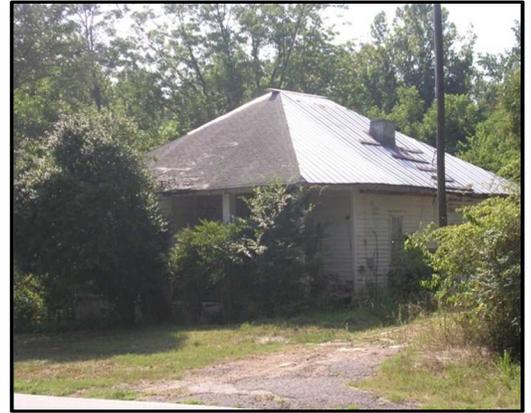
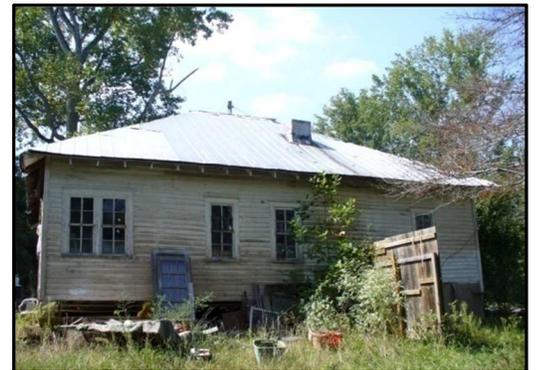
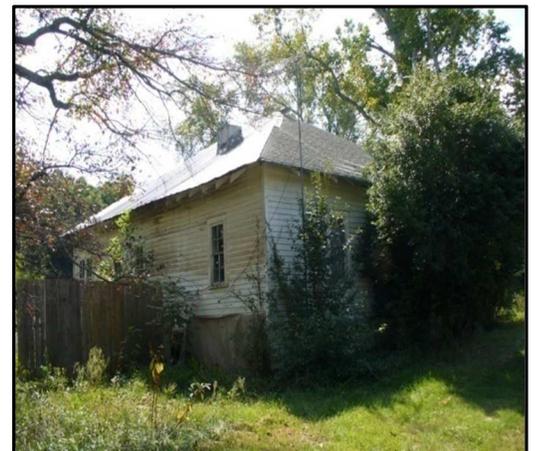
The residence is constructed of wood frame with a hipped roof and inset front porch. The foundation is comprised of 8" x 12" brick masonry piers. The floor framing consists of 2" x 8" timber joists that are 15", 16", and 17" on center. The joists rest atop 6" x 8" hewn timber sills. The wood frame walls are 5 1/2" thick and are comprised of 2" x 4" studs on 16" centers. Exterior walls are clad with 1/2" x 5 1/2" clapboard with a 4 3/4" reveal. The house has 1" x 4" corner boards at each corner of the house with 1" x 2 1/2" wood trim.

The house has a front porch that is inset within the main roof at the northwest corner of the house. The porch measures 16'-7 & 3/4" by 8'-1 1/2" and consists of 135 square feet. The portion of the roof over the porch is supported by two 10" x 10" wood posts supported by 16" x 16" brick piers. The posts and piers are separated by a 12" wood cap with quarter-round trim. The porch ceiling consists of 1" x 2 1/2" beadboard. The porch flooring consists of 1" x 5" and 1" x 7" flush boards. The porch is accessed from the west side of the house via three-step wood frame stairs.

Figure 135:
Front Oblique View of 9791 State Route 124
(photographer facing southeast)

Figure 136: Side of 9791 State Route 124
(photographer facing west)

Figure 137:
Rear Oblique View of 9791 State Route 124
(photographer facing southwest)

Although the residence is a contributing historic resource in the existing Braselton NRHP District and represents the early 20th century bungalow house type with Craftsmen elements being constructed in Braselton at that time, the house is slated to be demolished as part of the upcoming intersection improvements for State Routes 53 and 124.
